## STANDARDS FOR RESTORATION & GUIDELINES FOR RESTORING HISTORIC BUILDINGS

# Restoration

## Standards for Restoration

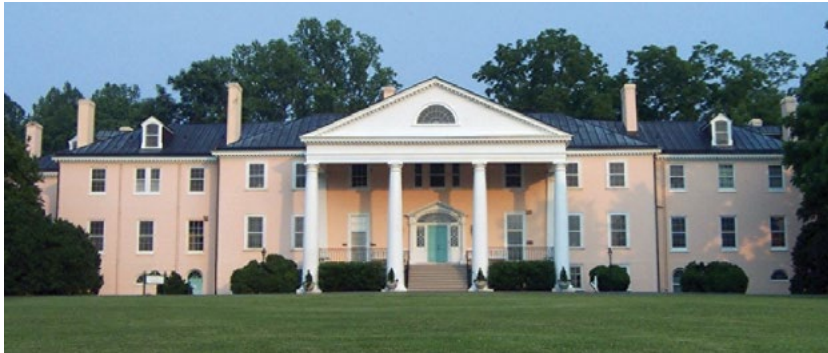
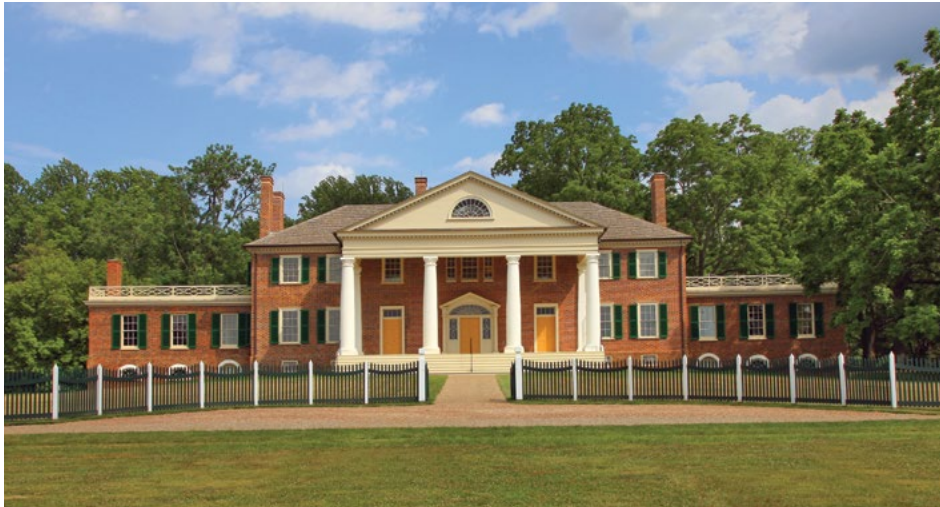
[1] (a) When it was acquired by the National Trust for Historic Preservation in the 1980s, Montpelier in Montpelier Station, VA, the home of James and Dolley Madison, had been much altered and enlarged since it was first constructed. Based on historical documentation and research, Montpelier was accurately restored to its 1820s appearance when the president and his wife lived there (b). *Photos: Courtesy of The Montpelier Foundation.*

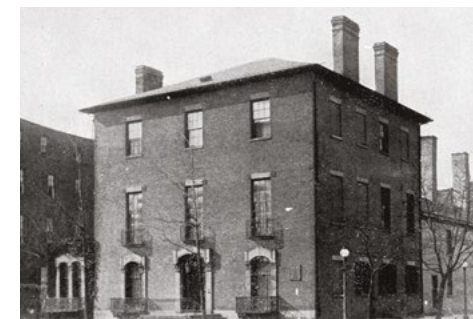
[2] (a) Decatur House in Washington, DC, was designed by William Henry Latrobe and constructed in 1816. (b) In the late-19th century, the façade was “modernized” by removing the limestone lintels on the first floor and replacing them with decorative sandstone lintels in the style of the period. (c) In the mid-20th century, the house was brought back to its original appearance based on historic documentation. Photos: The White House Historical Association and Decatur House, a National Trust Site.

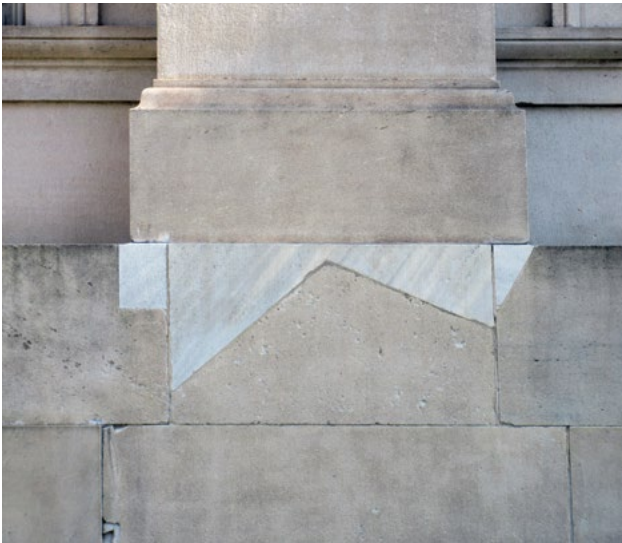
[3] **Not Recommended:** Although the Dutchman stone repair has been well executed, the replacement stone is not a good color match.

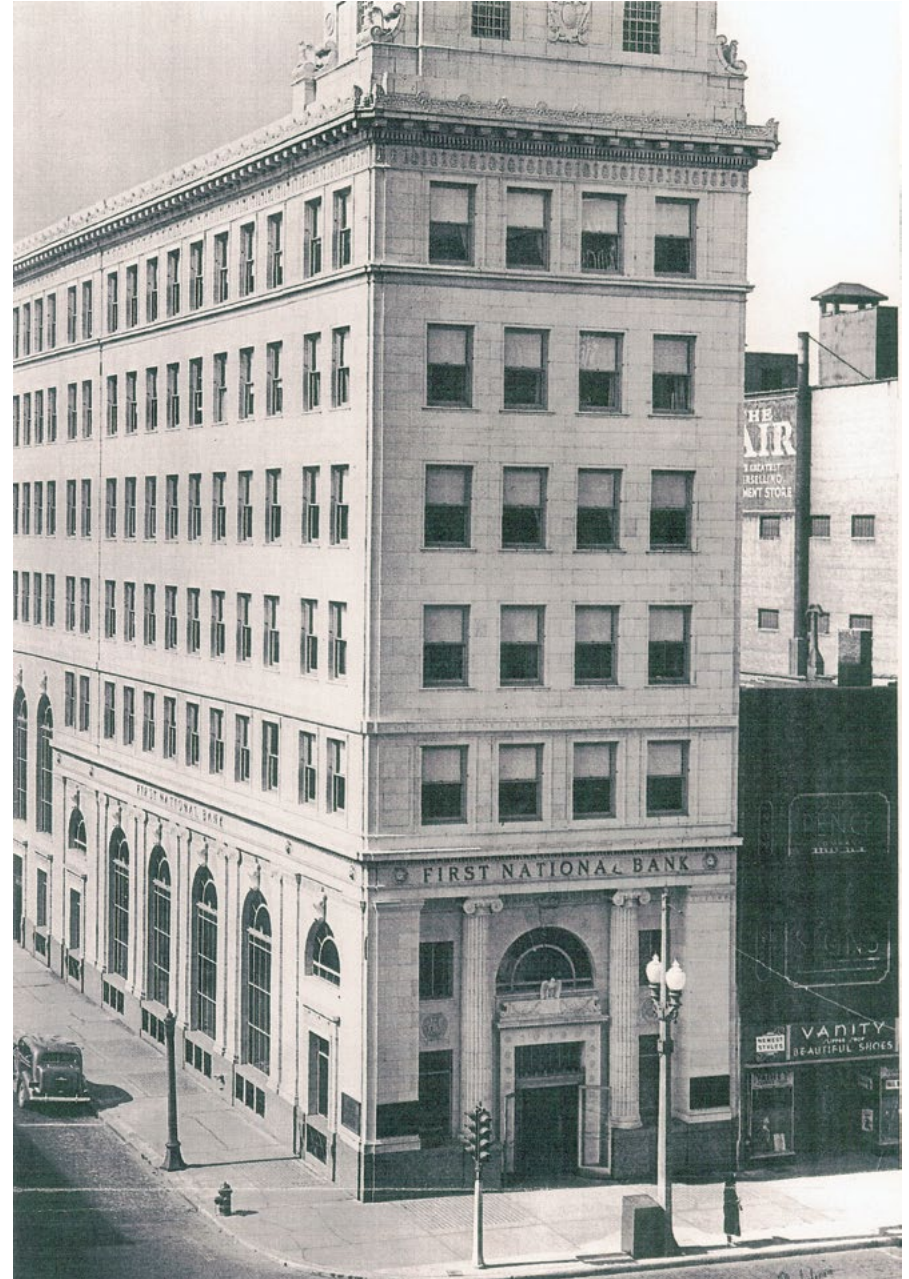
[4] (a) Over the years terra-cotta cladding had been replaced on the lower floors of this early-20<sup>th</sup> century bank building with a storefront and incompatible windows. (b) A 1936 photograph of the building provided the documentation to restore its historic appearance. (c) Glass fiber reinforced plastic (GFRP) was chosen as a substitute material, and samples were made in a variety of colors and textures to obtain the best match for the missing and damaged terra cotta. (d) This photo taken after restoration shows that the GFRP replacements successfully blend in with the original terra cotta. Photo (d): Blamonet at English Wikipedia.

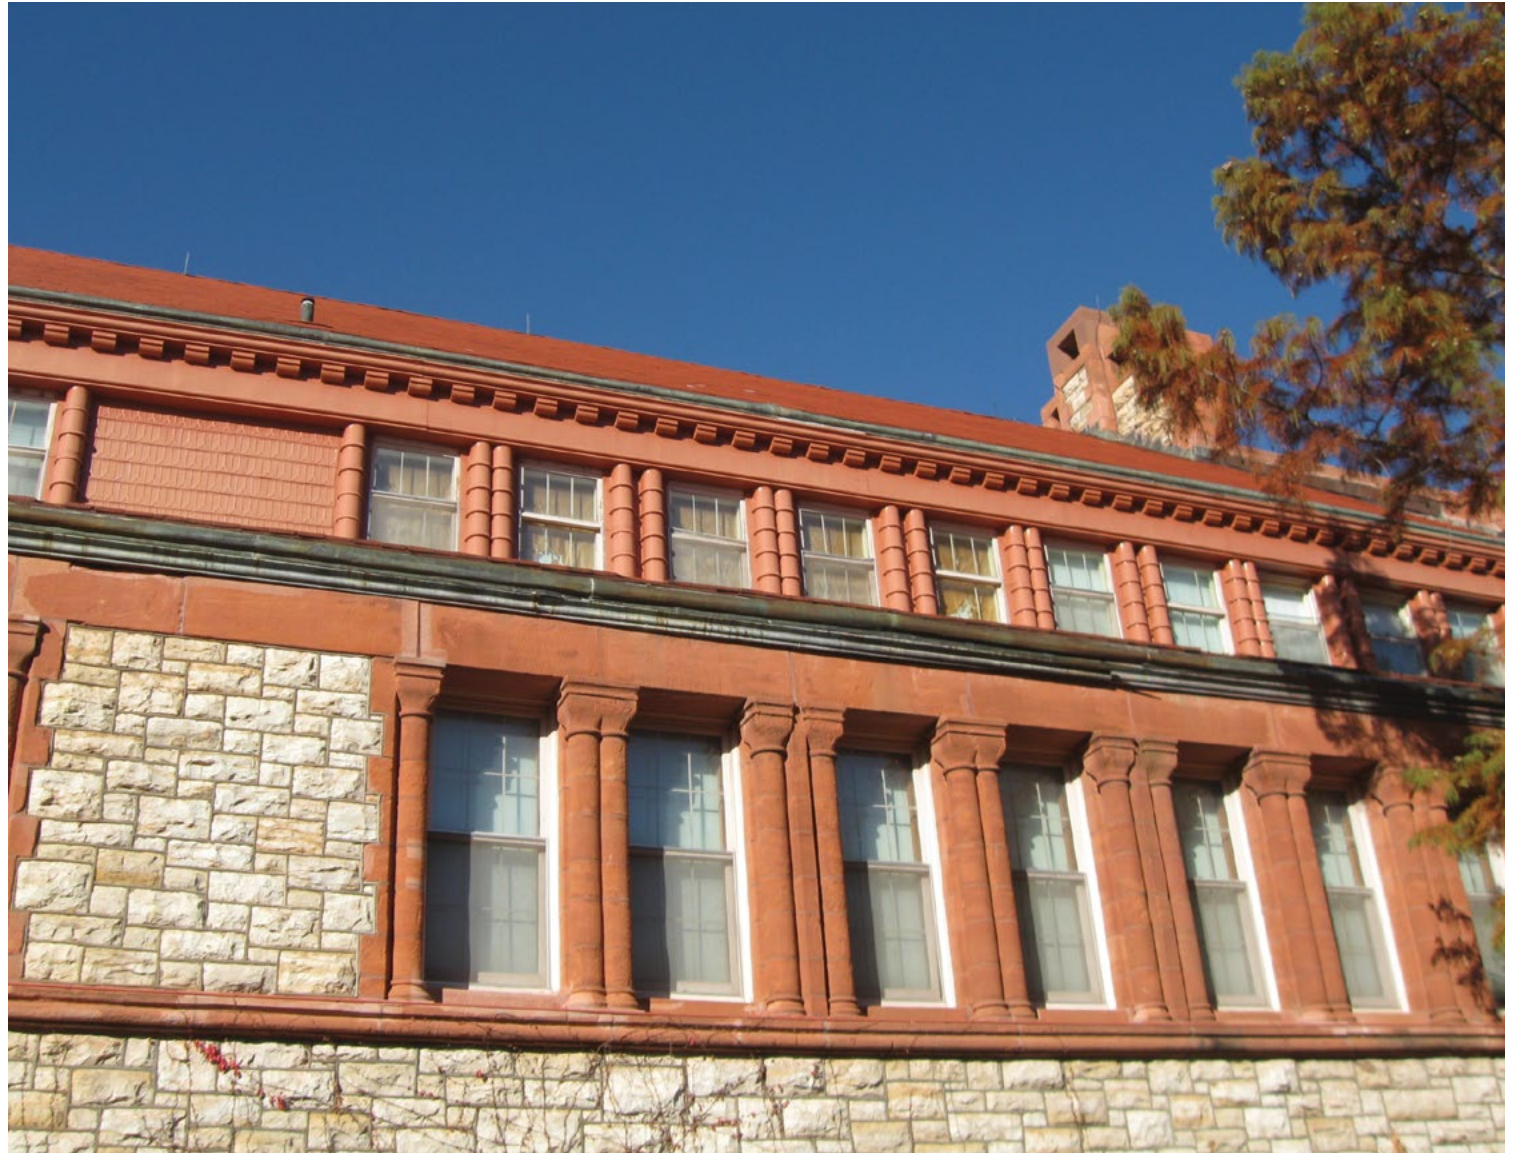
[6] Preliminary work before starting restoration revealed that the columns and the decorative shingles ornamenting the top floor of this historic building were fabricated of metal to imitate the red sandstone used elsewhere on the building.

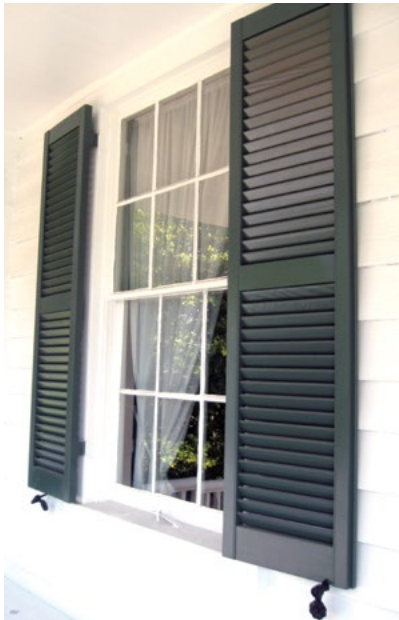
[9] Historic window and shutter hardware such as that shown here should be retained and repaired in a restoration project.

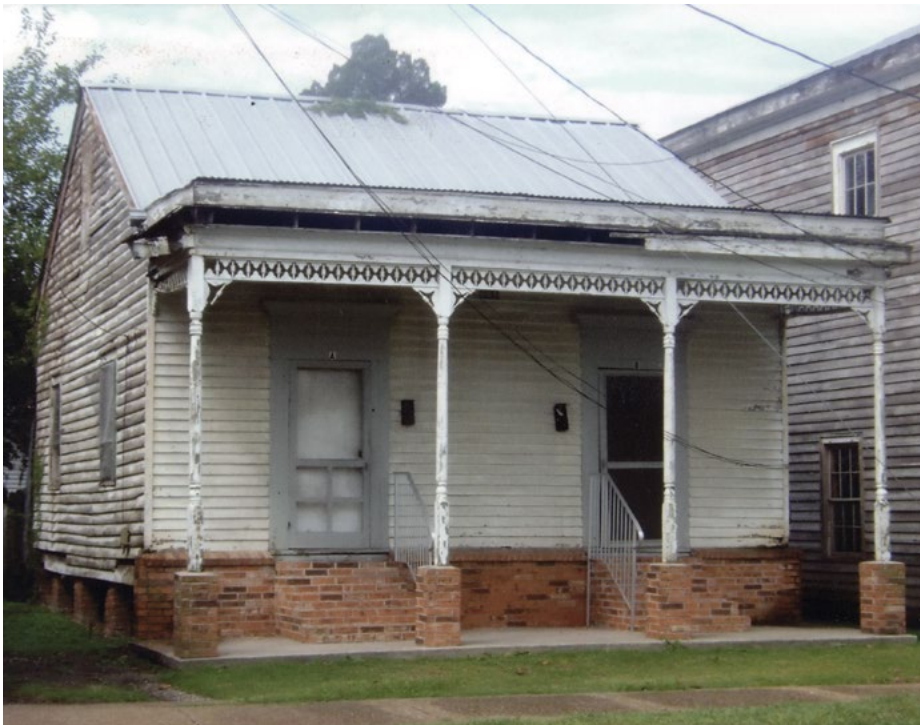
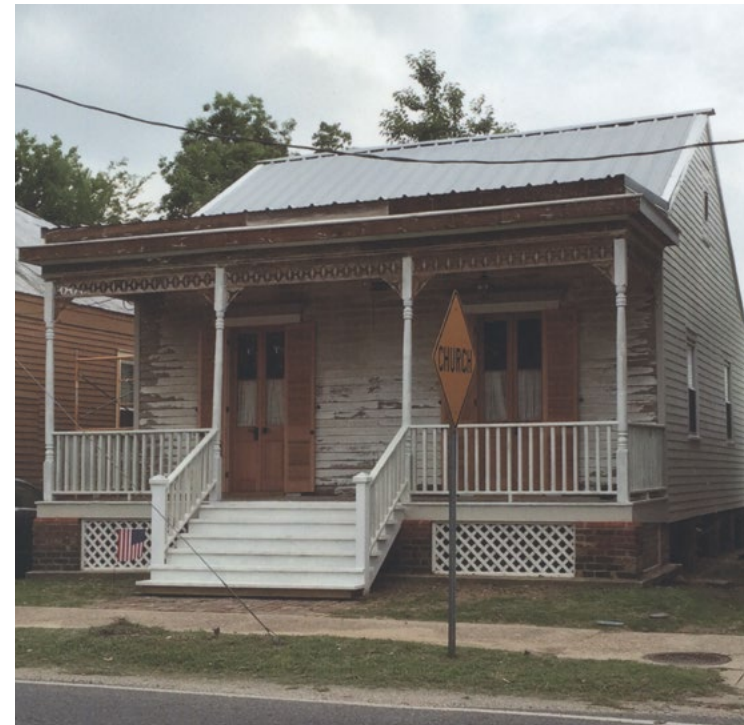
[10] (a) The entrance of this house had been altered over the years, including removal of the porch floor and steps. (b) This photograph shows the house after the porch and steps were restored to their historic appearance.

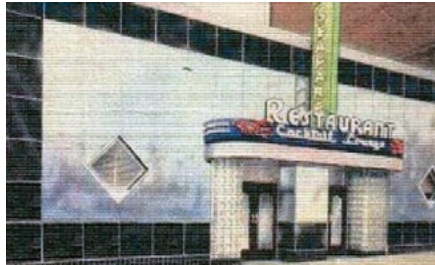
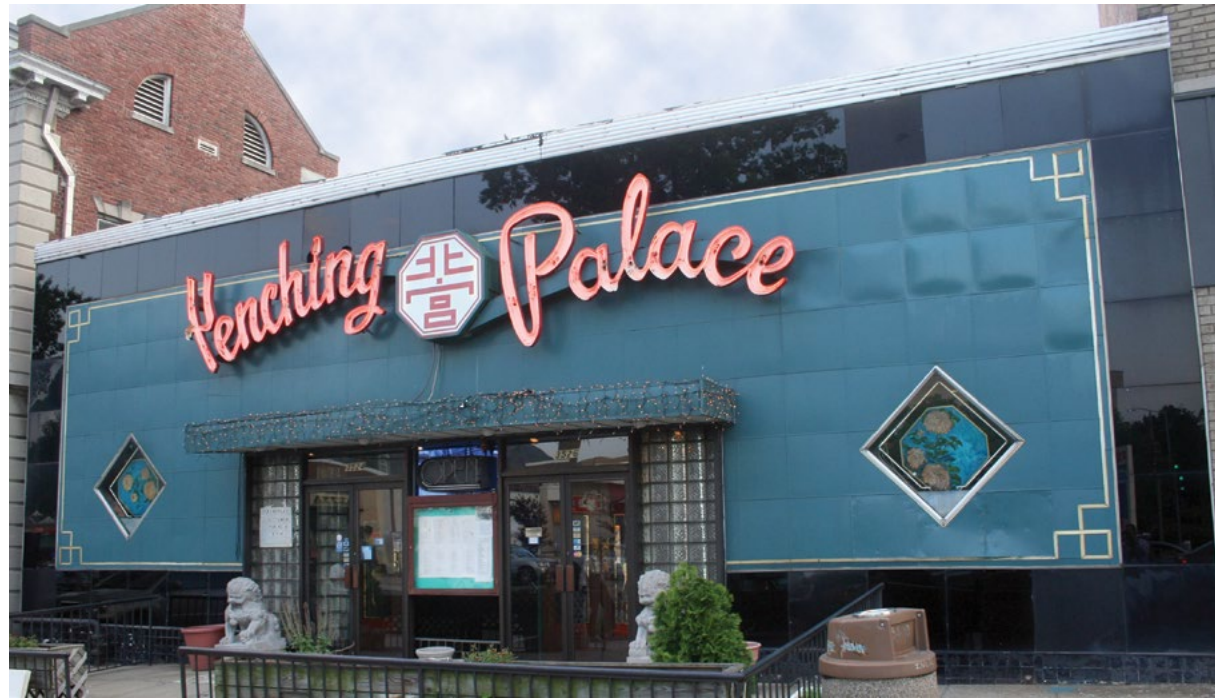
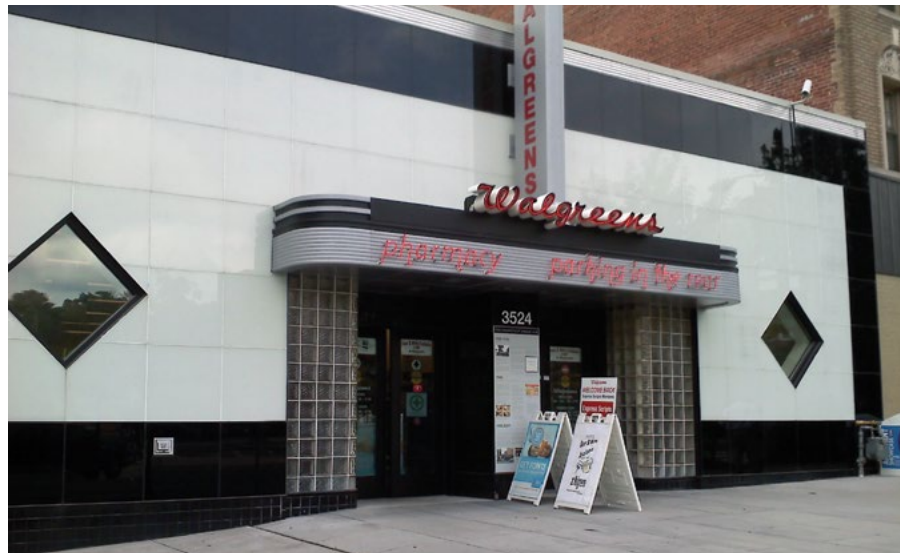
[11] (a) Some of the materials on the front of this historic building had been previously replaced, but the façade retained its essential distinctive features and design. (b) A vintage postcard of the building (far left) provided sufficient documentation to restore the façade to its historic 1945 appearance, using spandrel glass as a replacement for the original Carrara glass (c). Photo (b): Courtesy Kelsey & Associates.

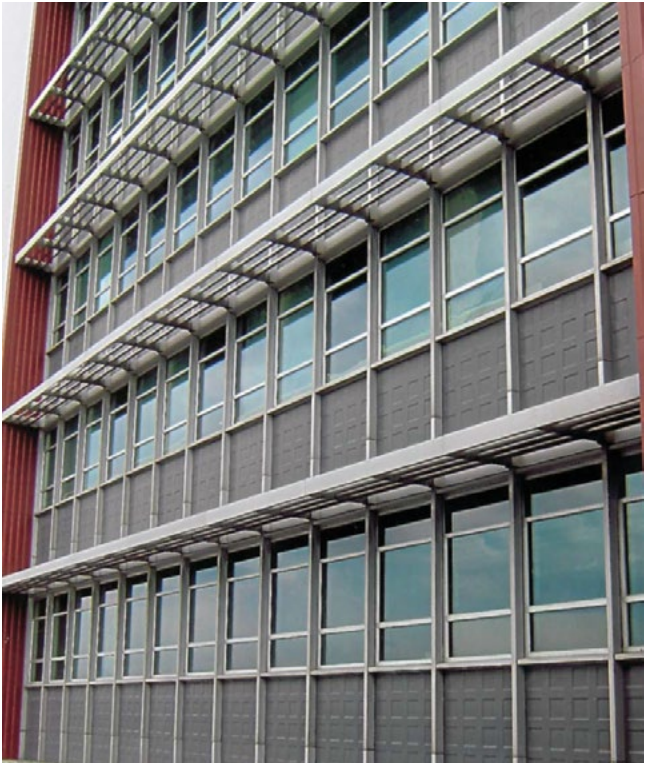
[12] This historic curtain wall features a distinctive variety of panel types which must be repaired or replicated in a restoration project if any are damaged or missing.

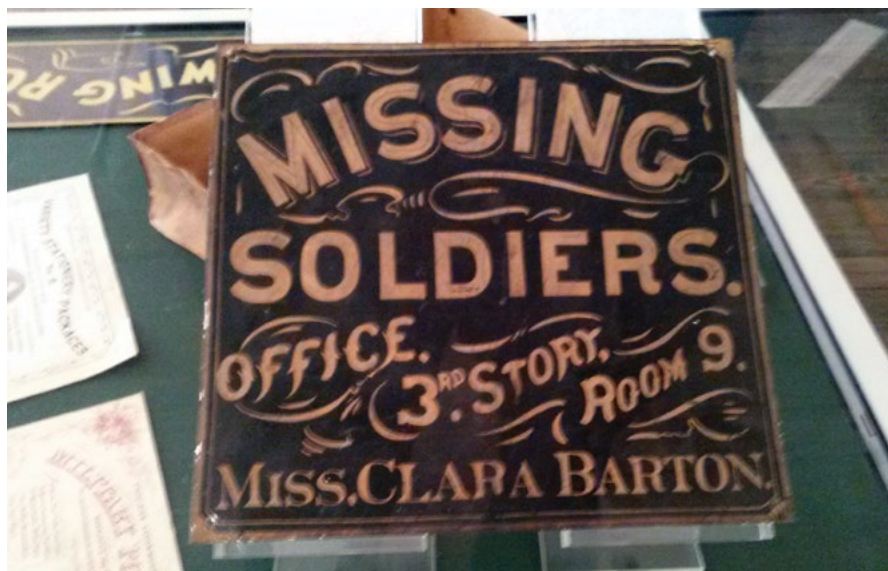
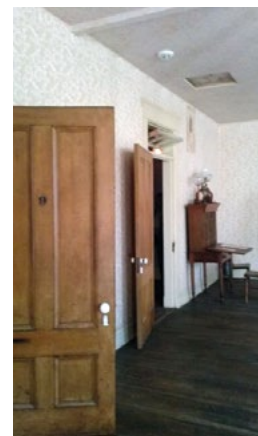
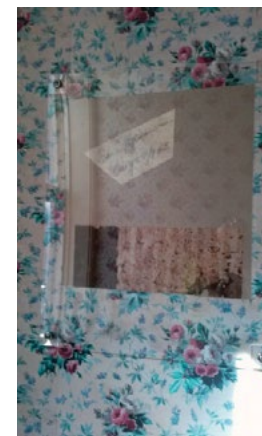
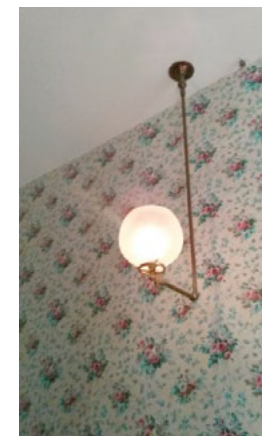
[13] (a) In the 1990s the Missing Soldier's Office—established by Clara Barton at the end of the Civil War—was discovered still extant on the third floor of a building in Washington, DC, that was slated for demolition. The office was restored to its historic appearance using physical and documentary evidence. The original numeral '9' is still on the door to the office, and wall paper was reproduced from scraps found on the walls (b-d).

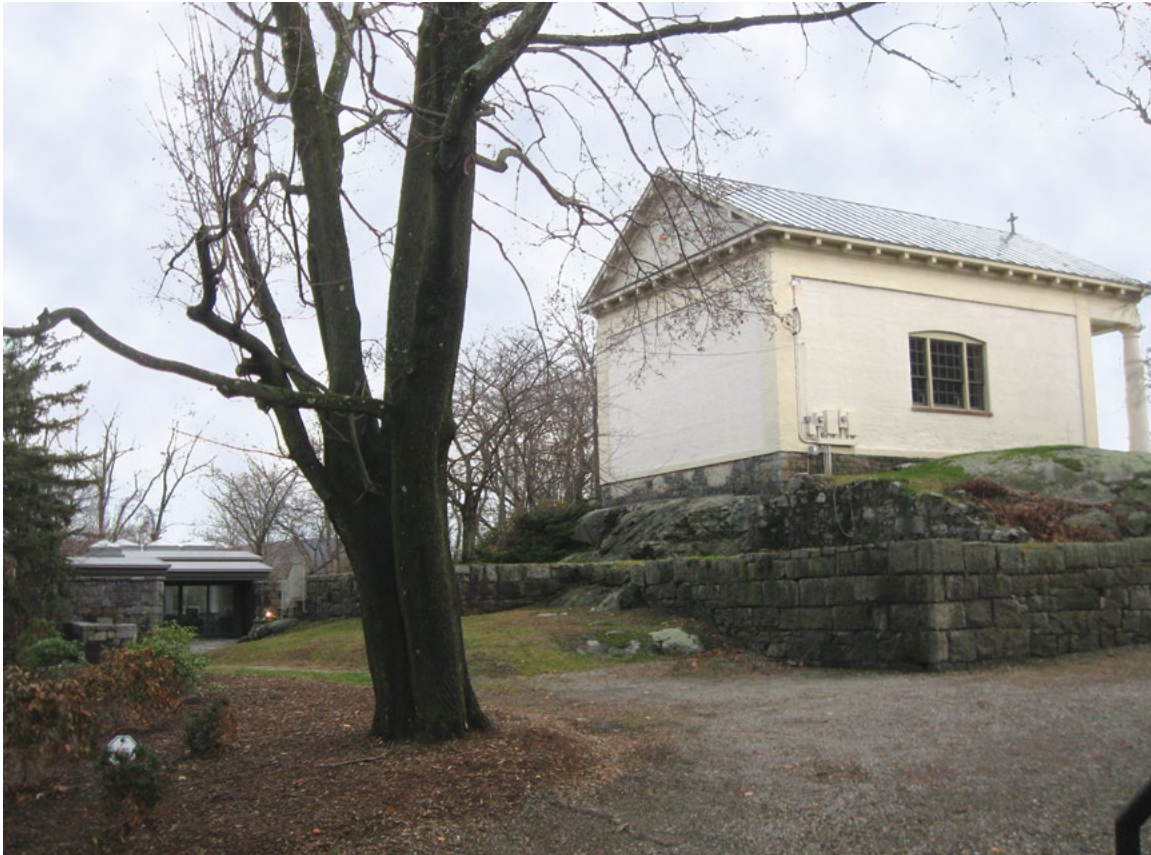
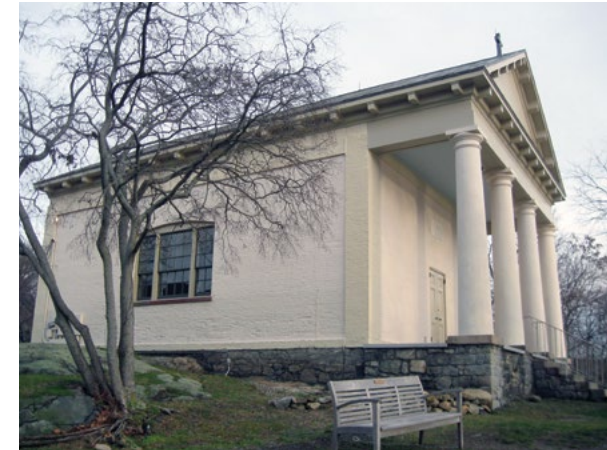
[18 a-b] The historic Chapel of Our Lady in Cold Spring, NY, is situated on a rocky promontory overlooking the Hudson River. Installing an accessible ramp would greatly compromise the character of the building and the site. However, an audio-visual program available in a separate building—located where it would not impact the character of the site, such as this small pavilion at the rear of the property—could provide visitors otherwise unable to access the Chapel an opportunity to experience the site.

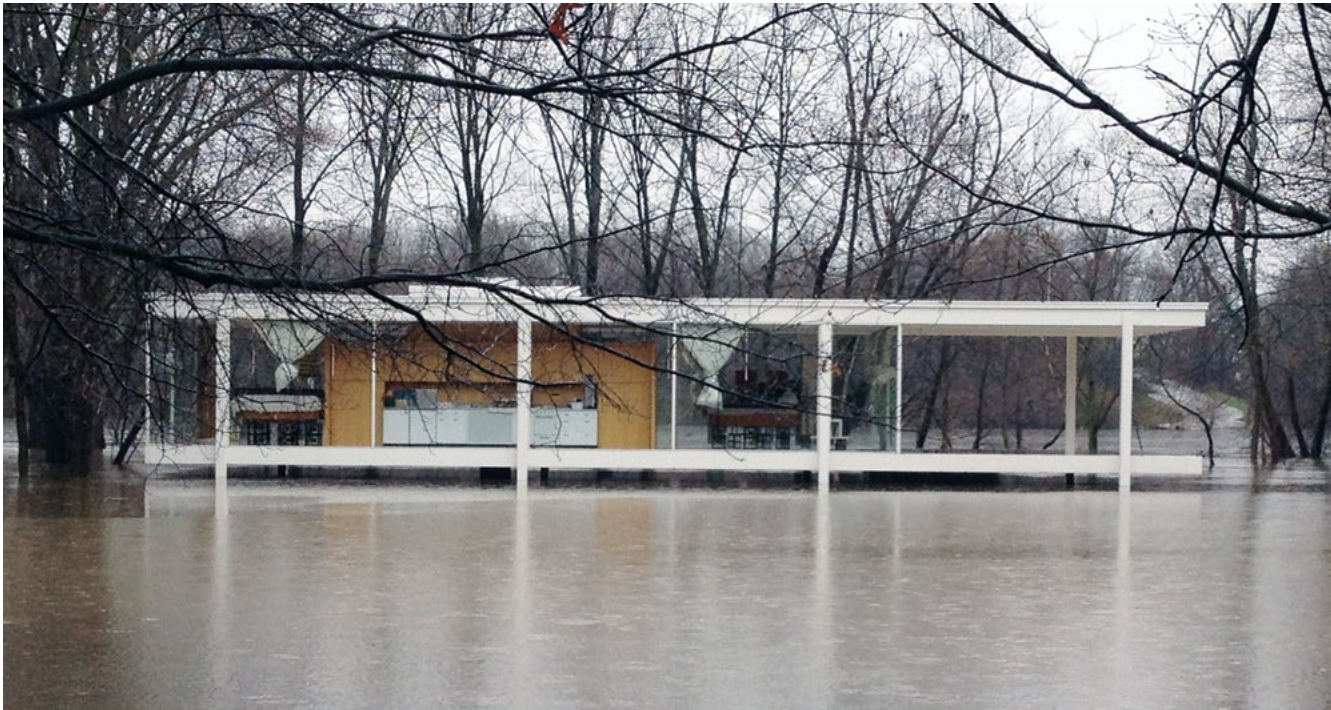
[19] The 1951 Mies van der Rohe-designed Farnsworth House, Plano, IL, was built close to the Fox River, which is increasingly prone to floods. To preserve the house in its original location, historic preservation architects and engineers continue to explore ways to protect it from the flooding, including a possible system that would lift the house above the flood waters and lower it back to the ground. Photo: Courtesy Farnsworth, A Site of the National Trust for Historic Preservation.

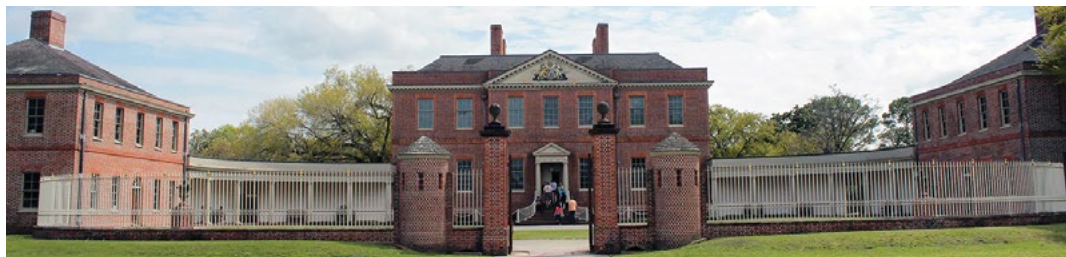
[1 a-b] Tyron Palace, New Bern, NC, was designed by John Hawks in 1767 for Governor William Tyron. It was completed in 1770, but destroyed by fire in 1798. The palace was reconstructed in 1959 based on the original plans, and on its original foundation, which was found 5 feet below the street, with the help of the 1767 drawing. Photo: Courtesy Tyron Palace, New Bern, NC. Drawing: Courtesy of the State Archives of North Carolina.

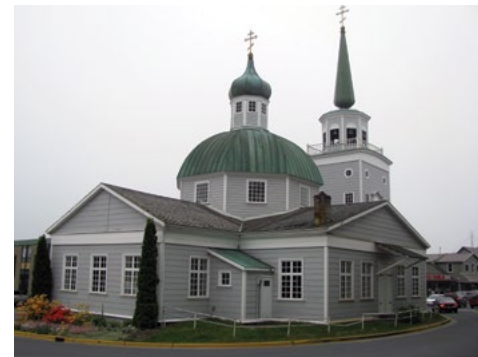
[3] The Cathedral of Saint Michael the Archangel, built in the early 1840s in Sitka, AK, was devastated by fire in 1966. It was reconstructed using measured drawings done in 1961 by the Historic American Buildings Survey (HABS). While the original cathedral was built of logs covered on the exterior with wood siding, its replacement is a fire-resistant structure with concrete and steel walls that replicates the historic building's appearance. Photo: Barek at Wikimedia Commons.

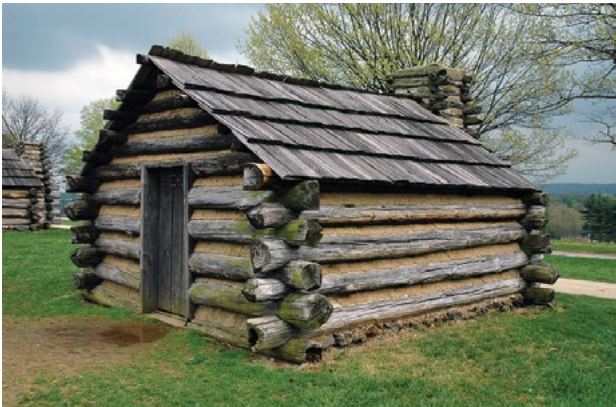
[7] The Muhlenberg Brigade Huts are reconstructions of nine log huts erected in 1777 at Valley Forge during the Revolutionary War. They have been reconstructed on the historic road with logs cut with modern power tools and finished with cement, unlike the original logs which were hand hewn and finished with traditional chinking. *Photo: Rdsmith4 at Wikimedia Commons.*

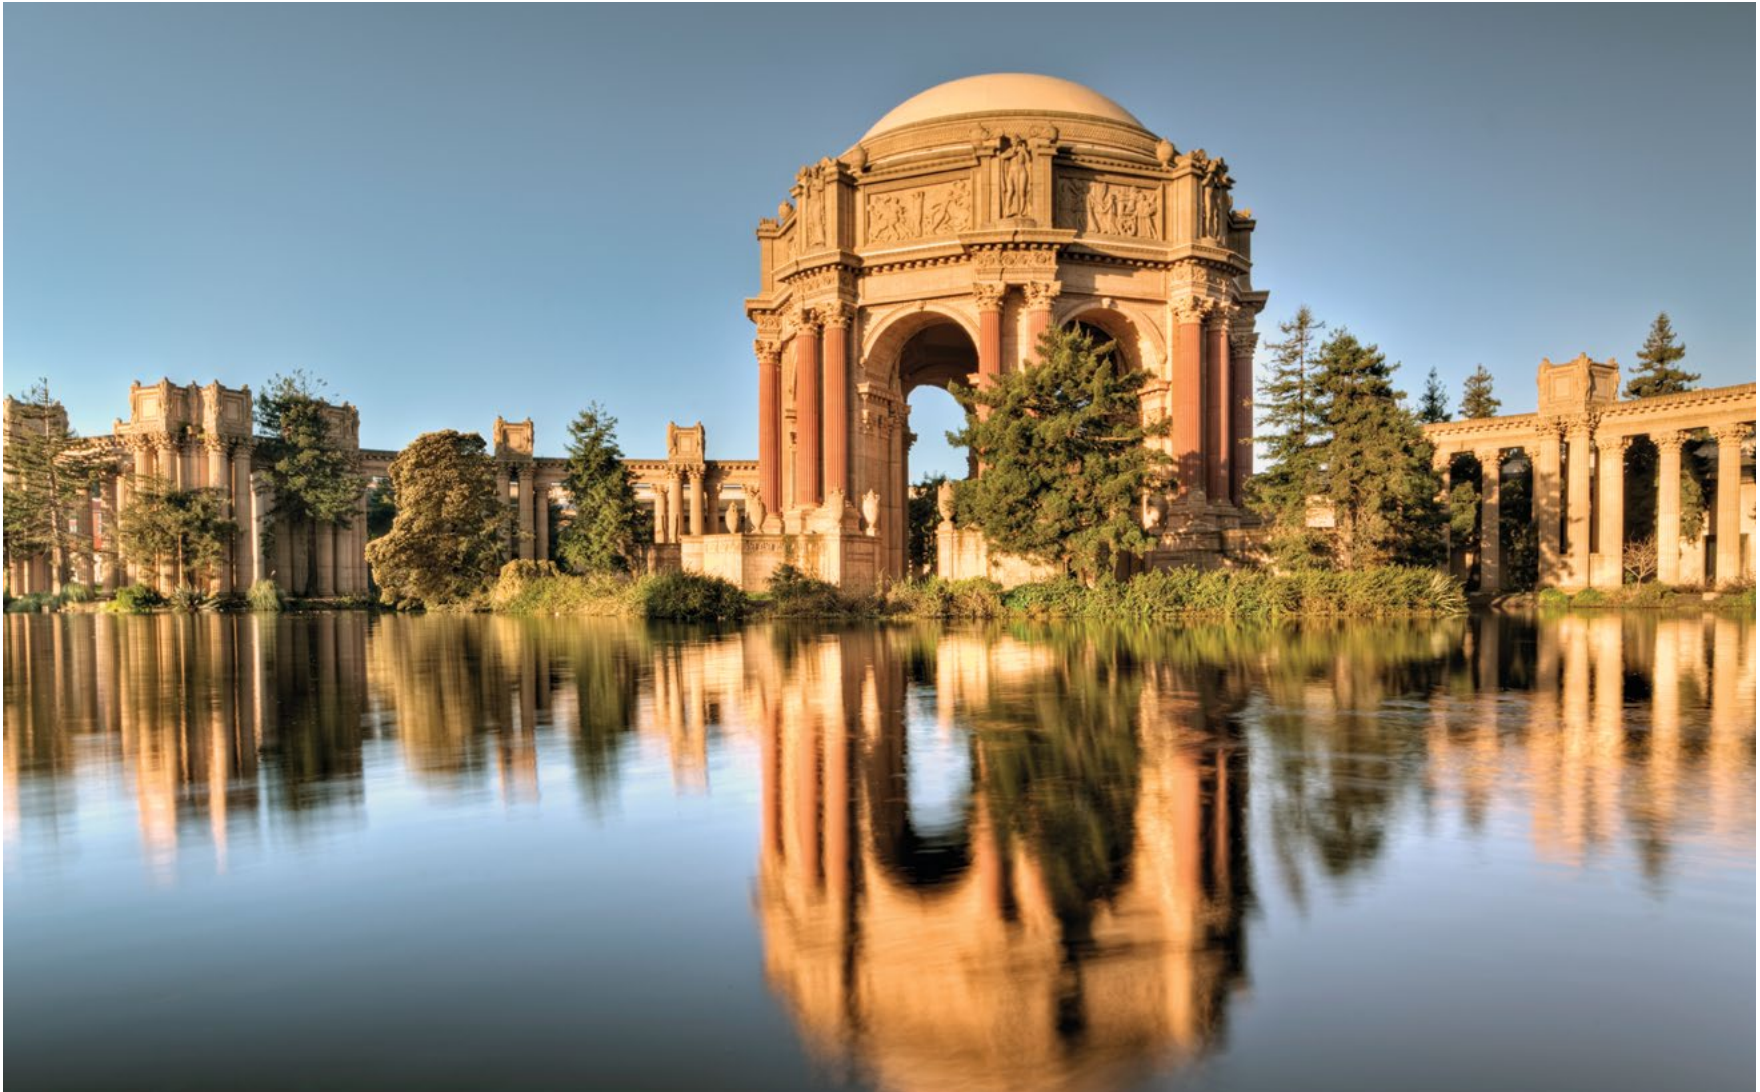
[8] The Palace of Fine Arts was designed by Bernard Maybeck and built for the 1915 Panama-Pacific Exposition in San Francisco. The pavilion was intended to be temporary and, although it had a steel structure, the exterior was finished only with stucco, an impermanent material composed of plaster and fiber. The building was not torn down after the exposition, and it eventually fell into ruin. In 1964, all but the steel structure was demolished, and the building was reconstructed with lightweight poured-in-place concrete. *Photo: KevinIcole at Wikimedia Commons.*
